Re: East Hennepin Avenue Site Receptor Survey

This letter summarizes the results from our receptor survey for the East Hennepin Avenue site. The scope of the receptor survey was as specified in your January 3, 1997 letter to the MPCA.

EAST HENNEPIN AVENUE SITE Proposed Groundwater Receptor Survey Search Area

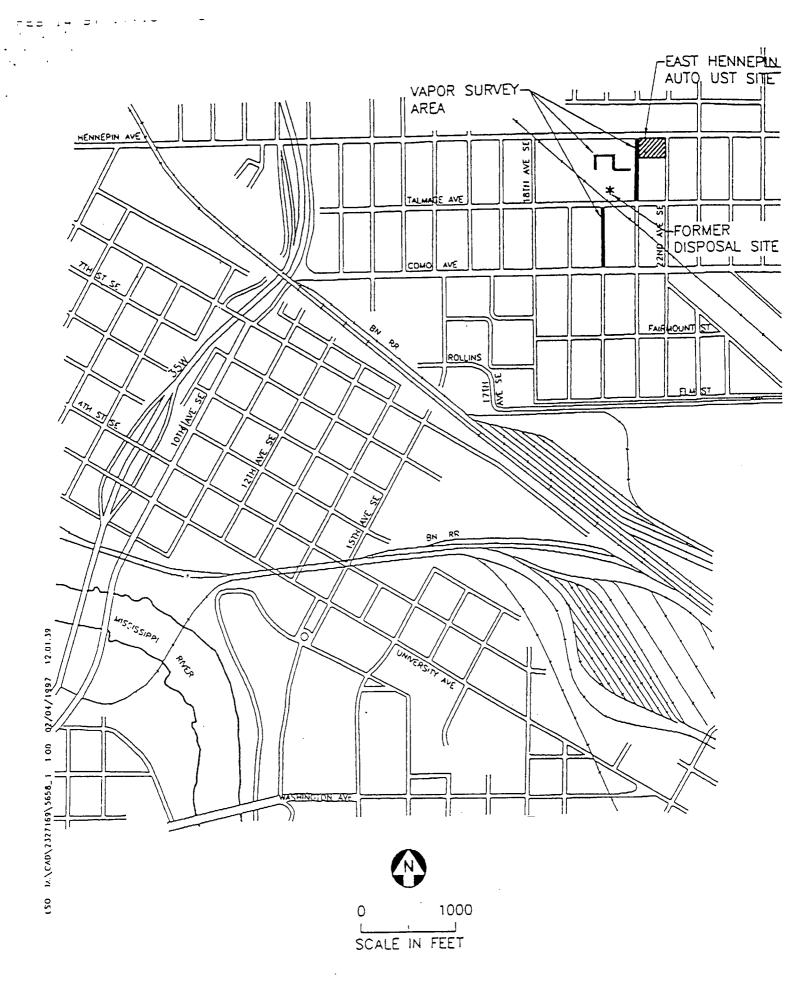
The VRA survey locations are shown on Figure 1 and the results are summarized on the logs in Attachment A.

The sanitary sewer on 21<sup>st</sup> Street SE begins at the intersection of Talmage Avenue and 21<sup>st</sup> Street (Sample location #5). Sewage flow is to the north. The sanitary sewer on 20<sup>th</sup> Street SE begins at Talmage Avenue and 20<sup>th</sup> Street SE (Sample location #6). The sewage flow is to the south.

Neither organic vapors exceeding the practical instrument detection limit nor vapors exceeding the LEL were detected in the sewage headspace or the sewer manhole atmosphere samples. This data indicate the absence of a vapor risk associated with the sanitary sewer systems in the immediate vicinity and immediately downgradient of the former source area.

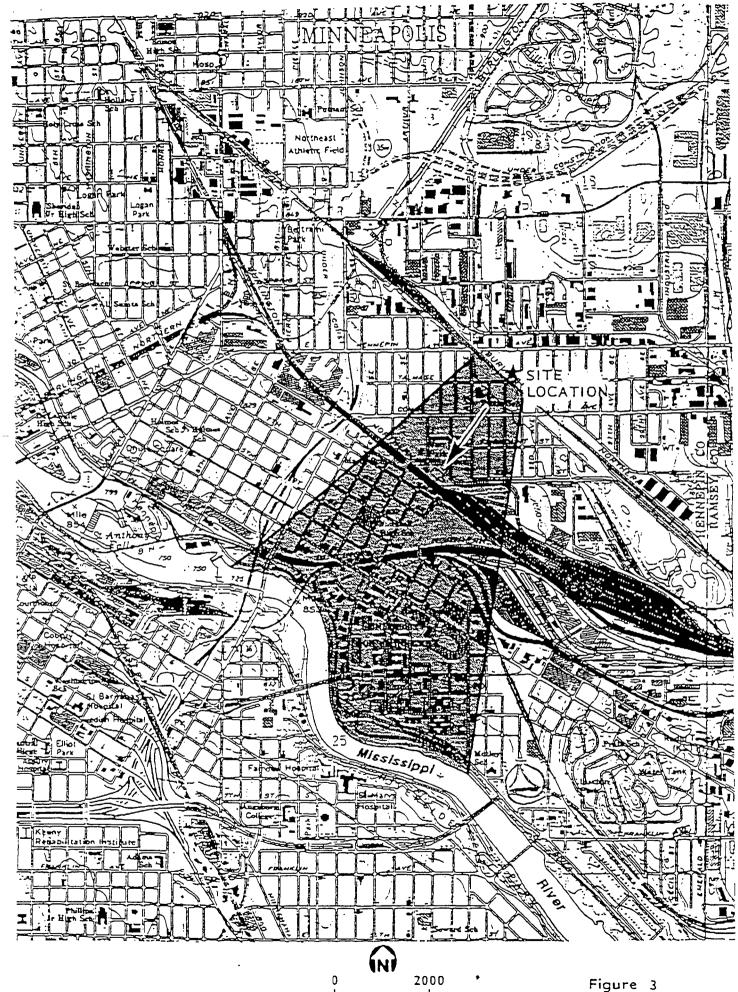
The results from our review of existing public data base records identified 21 wells (not including monitoring or groundwater pump-out wells) within the search area (Figure 3). A summary of the well search data is attached as Table 1. Figure 4 shows the well locations.
